## Contents

## EFFECT OF AGGREGATE TYPE ON THE BEHAVIOR OF THERMALLY TREATED SELF-COMPACTED CONCRETE

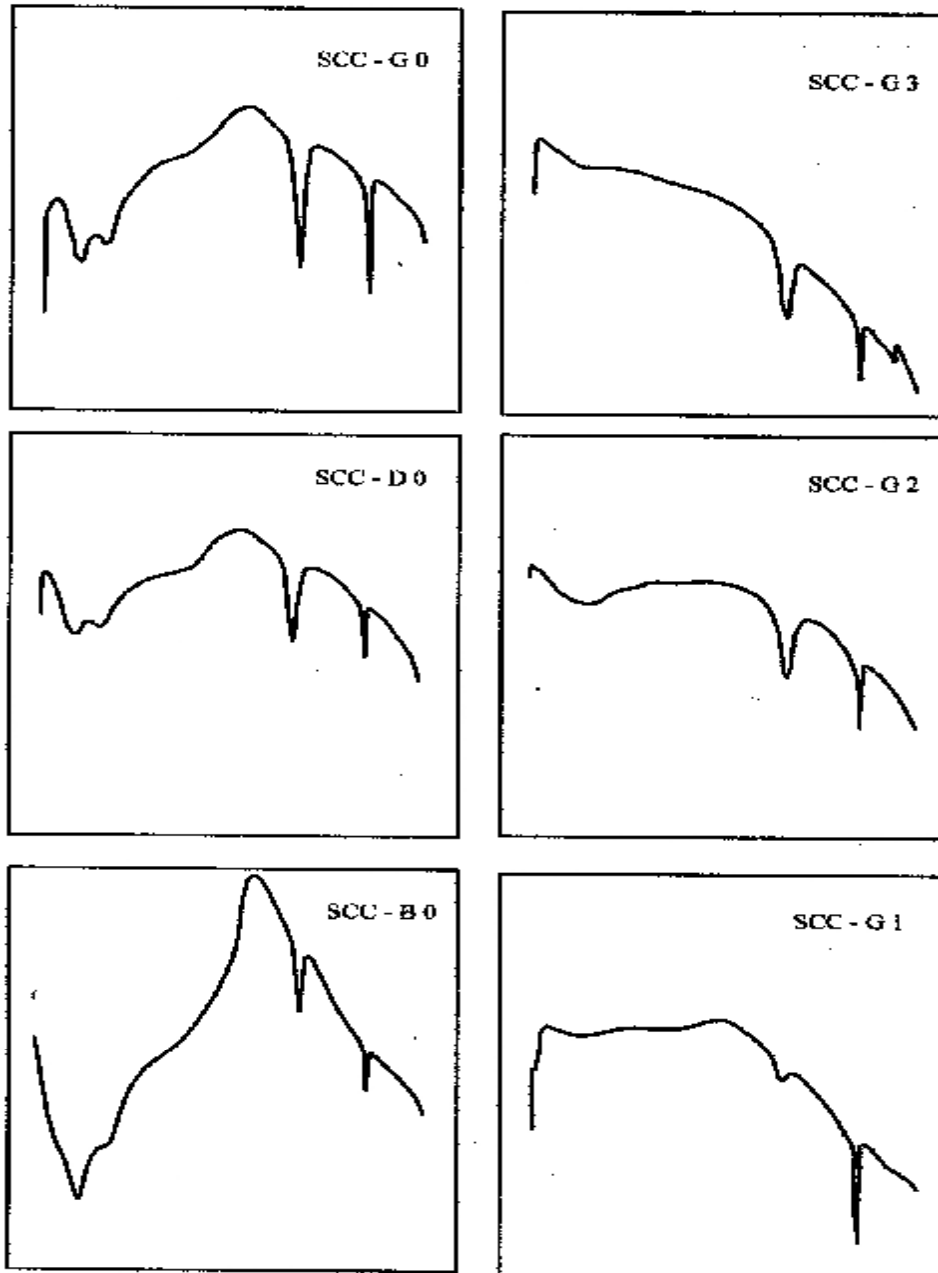
Fig. 12: The DSC Thermo grams of SCC Mixes with Different Types of Coarse Aggregate Exposed to 600° C for One, Two and Three Hours

Ca(OH)<sub>2</sub> phase reached to 2.72, 4.26 and 8.51J/g for the first peak in the mixes SCC-B0, SCC-D0 and SCC-G0 respectively. While reached to 0.556, 0.781 and 1.91 for the second peak. Also, the figure demonstrated that the enthalpy of Ca(OH)<sub>2</sub> phase reached to 0.458, 4.09 and 4.16J/g for the first peak in the mixes SCC-G1, SCC-G2 and SCC-G3 respectively. While reached to 1.63, 1.27 and 0.948 for the second peak. So, it is clear that the different type of coarse aggregate and also, high temperature have great effect on the performance of SSC mixes exposed to 600° C for one, two and three hours.

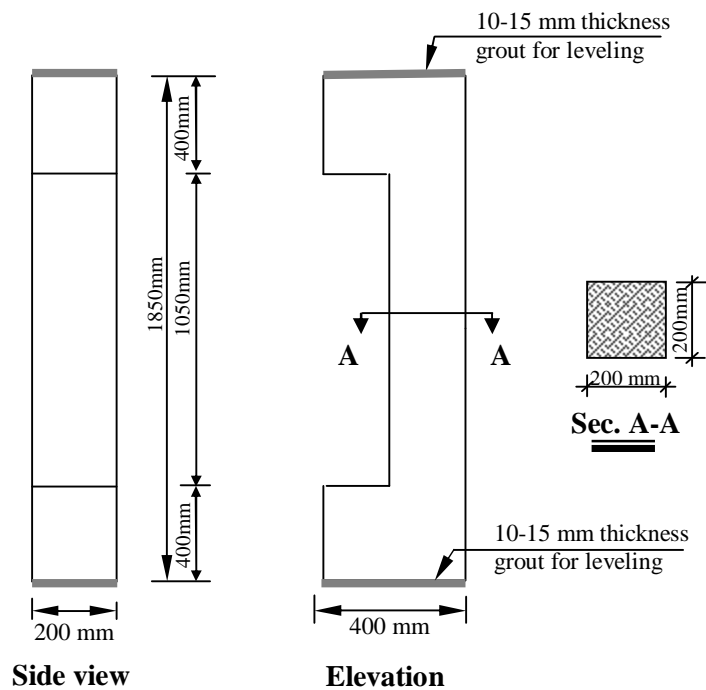
**Fig. 1: Concrete Dimensions of the Specimens**

Seven RC column specimens were tested under the effect of eccentric compression loading. Six columns were strengthened with different FRP schemes while one column was kept unstrengthened as control specimen. All specimens have identical concrete dimensions. The column had a square cross section of 200x200 mm, 1050 mm clear height and 1850 mm overall height including corbel heads. The dimensions of the top and bottom corbels were 200x400x400 mm. Those corbel heads were introduced to prevent premature failure at the end regions of the columns. Figure 1 shows the typical concrete dimensions of the specimens.

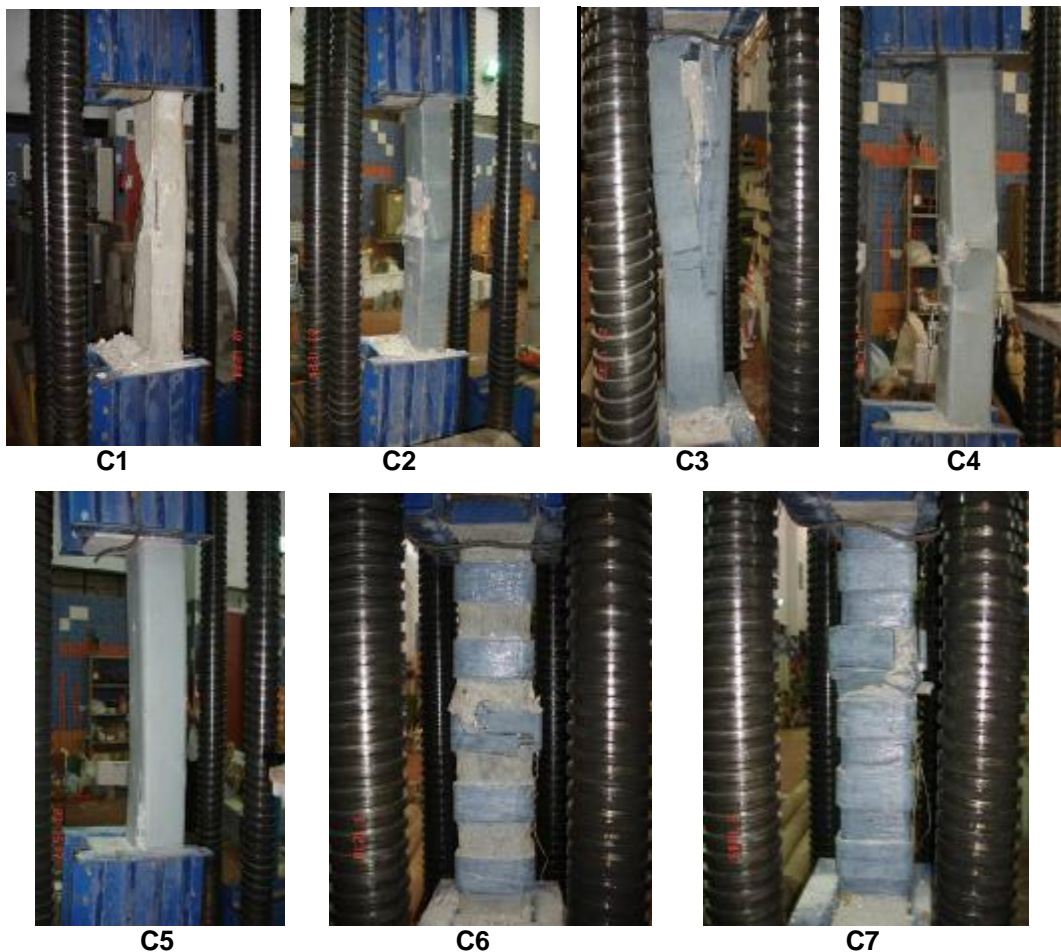
**Fig. 5: Appearance of the Columns after the Conclusion of the Test**

Five mechanisms of failure were observed and recorded during the experimental work. Figure 5 shows the appearance of the column specimens after the conclusion of the test. The unstrengthened column C1 showed the typical cracking behavior of a reinforced concrete column subjected to small eccentric compression. Cracks appeared in the tension face and the concrete cover spalled off in the compression face. At a later stage, the spalling of the cover extended to the side faces. At ultimate load the concrete crushed suddenly causing a significant drop of the load. The longitudinal reinforcing bars experienced inelastic buckling between hoops. The failure of the strengthened columns followed different mechanisms based on the strengthening method.

The failure mode of columns C2 and C4 strengthened using regular full length FRP wrapping started with horizontal cracks of the FRP laminates in the tension side. A fracture sound of the concrete in the compression side was observed. The existence of the FRP wrapping prevented tracking the cracks in concrete cover. Finally, the failure was due to sudden rupture of FRP sheets followed by crushing of concrete. Also, the longitudinal reinforcing bars buckled between hoops in the zone where FRP ruptured. This mode was compression failure; however, it is less brittle than the failure of column C1.

The sandwich FRP wrapped columns C3 and C5 showed horizontal cracks in the FRP laminates. At ultimate load, rupture of FRP wraps took place. The acrylic plates experienced horizontal cracks in the tension side and crushing in the compression side and the FRP laminate rupture. Finally, crushing of concrete in compression and buckling of longitudinal bars occurred.

Column C6 strengthened with sandwich strips experienced cover spalling off in the unconfined areas of the column between the strips. At later stages of loading the unconfined areas at mid height of the column showed crushing of concrete. This was followed by rupture of the sandwich FRP strips at the corner and the acrylic plate was separated from the laminate.

The failure mechanism of column C7 strengthened with combined regular and sandwich wrapping was different from that of column C6. First, the rupture of the regular FRP strip took place. This was followed by the rupture of sandwich FRP strip. The longitudinal reinforcing bars buckled between hoops in the region where the FRP ruptured and the concrete crushed in the compression side.

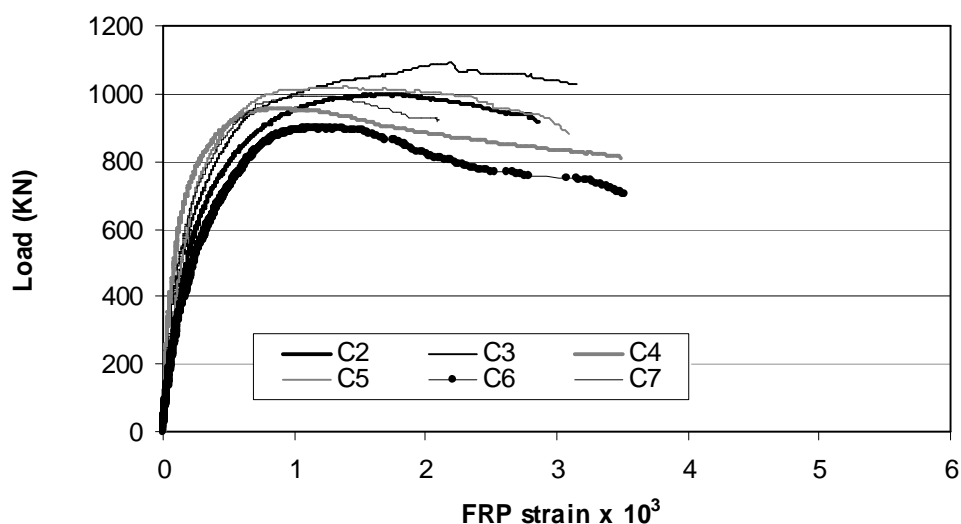
Fig. 6: Load-FRP Strain Relationship for the Tested Columns

At and beyond ultimate load, the FRP wraps acted more effectively and introduced high confinement pressure on the concrete section of the column. For columns C2 through C6, the failure transverse strain of FRP wraps at mid-height zone ranged from 0.0029 to 0.0036. On the other hand, column C7 strengthened with combined regular and sandwich FRP strips recorded a lower strain value in sandwich wrap that equals 0.0021 at failure. This can be attributed to its mechanism of failure that started with the rupture of the regular FRP wraps and consequently causing a load drop and a release of a part of the strain developed in the sandwich FRP wraps.

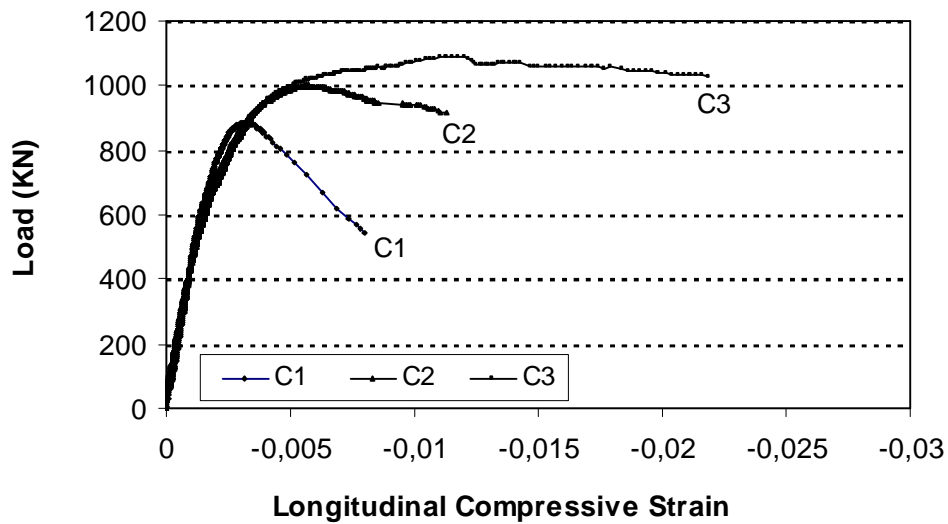
Fig. 7: Effect of Wrapping Method-CFRP Wraps

It can be concluded that the utilization of sandwich FRP wraps results in load and ductility enhancement higher than those of the regular wraps. It is worth mentioning that the load enhancement ratios of the eccentric columns tested in the current research are significantly lower than those reported by Mahmoud et al. [7] for sandwich FRP wrapped columns tested under concentric loading. This observation is in line with the results reported by Hadi [4]. He found that when load eccentricity is introduced on RC columns, the effectiveness of the regular FRP wrapping significantly decreases.

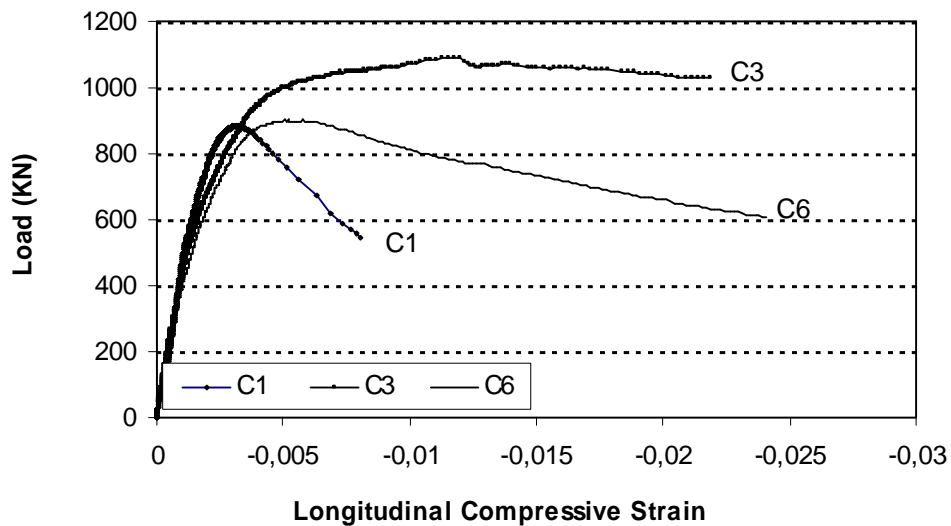
Fig. 11: Effect of Percentage of Sandwich Wrapping

The effect of percentage of sandwich wrapping was studied for full and partial wrapping. The load-longitudinal compressive strain relationships for columns C1, C3 and C6 are presented in Figure 11. Strengthening the column with full sandwich CFRP wrapping increased the ultimate load capacity by 24 percent compared with the control column. On the other hand, partial sandwich CFRP wrapping did not enhance the ultimate load carrying capacity of the column. This can be explained through the failure mechanism of the column provided with partial sandwich wrapping. It started with the compression failure in the unconfined zone and so made

the column performance dominated by its weakest zone, i.e. the unwrapped zone. Till further research is done in this area, it is recommended to use full sandwich FRP wrapping, if an enhancement in the load capacity is required.

The ductility of columns C3 and C6 increased by 320 and 162 percent compared with the control column, respectively. In other words, the enhancement in ductility for the partial wrapping was about half the value of the full wrapping. This can be attributed to the failure mechanism of the column provided with partial sandwich wrapping as explained above.

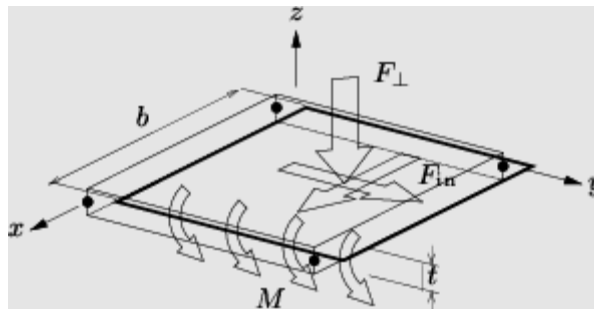
**Fig. 2: Flat Shell Element as defined in DIANA[12]**

The structural performance of bridges is proposed to be assessed by a detailed FEM analysis using the commercial software DIANA package [12]. The FEM analysis can confirm whether the serviceability conditions of the bridge (as deflection and cracking of the structural elements under the designed and actual acting loads) are compatible with the service tolerable limits. In this paper, a constitutive model for concrete including smeared crack model is implemented in the finite element analysis using flat shell elements Fig. 2.

The elements are basically combinations of a plane stress element and a plate-bending element and there is no coupling between membrane and bending behavior. Generally, the membrane behavior matches with plane stress element except the primary stresses, which are defined in terms of moments and forces, rather than Cauchy stresses. The bending behavior is based on the Mindlin-Reissner theory that conforms to Mindlin plate bending element. In the Mindlin-Reissner plate theory the transverse displacements and rotations of the mid surface normals are independent and obtained by employing an isoparametric interpolation respectively from the translations and rotations in the nodes; this technique includes transverse shear deformation. The shape functions used here are taken from Simo and Rifai [13] and from Andelfinger and Ramim [14].

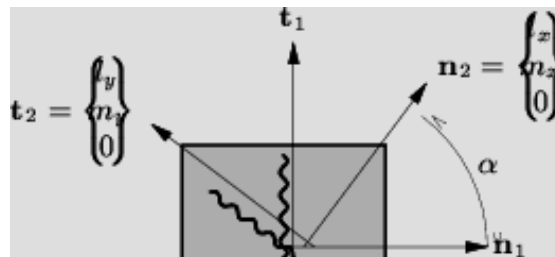
**Fig. 3: Multi-directional fixed crack model**

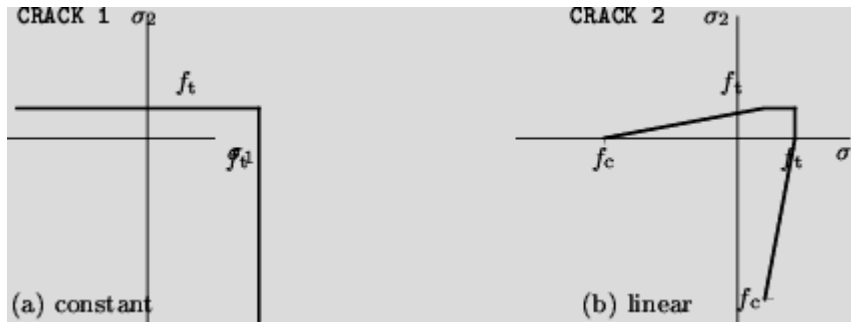
**Fig. 4: Crack initiation as function of tensile stress**

A fixed smeared crack model with a constant stress cut-off criterion is implemented in the analysis. The cut-off value equals the tensile strength of concrete corresponding to the concrete class as determined from the concrete cores of the existing concrete member, i.e. a crack arises if the major principal tensile stress exceeds  $f_t$  as delineated in Fig.4.

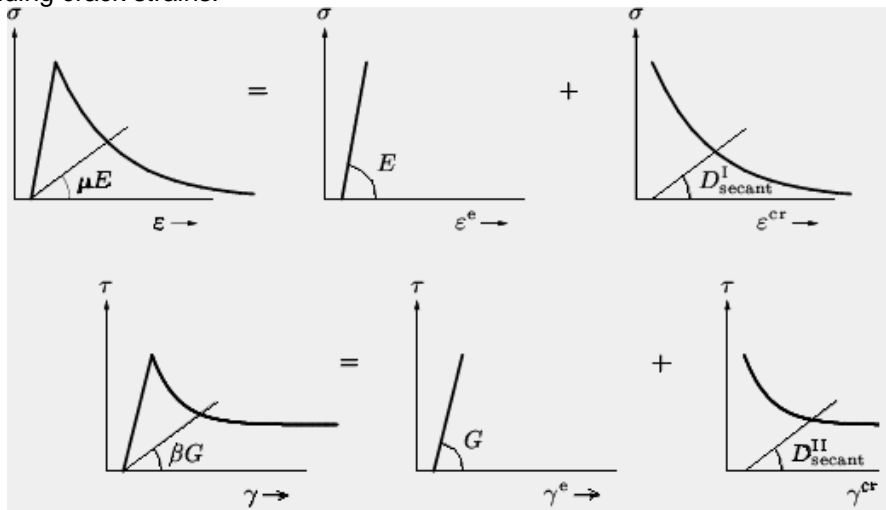
**Fig. 5: Relation between Traditional and Secant Crack Parameters**

The relation between the traditional cracking parameters --the reduction factor of the Young's modulus " $\mu$ " and the reduction factor on the shear modulus  $\beta$  can be derived as shown in Fig. 5 ignoring the coupling between the normal stresses and the shear stresses, as coupling results in unnecessary level of sophistication. Accordingly, the crack stresses are solely governed by the corresponding crack strains.

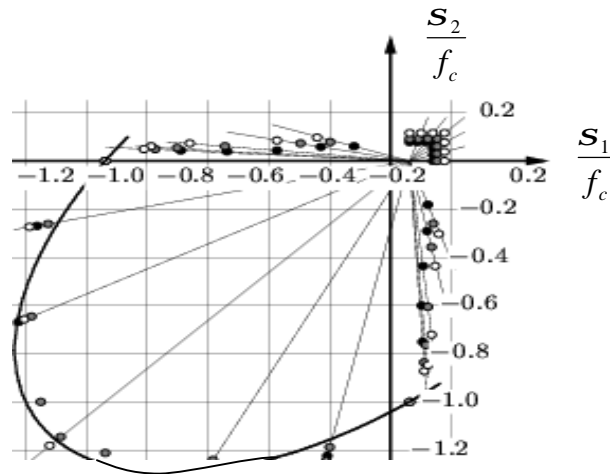
Fig. 7: Biaxial fit of Drucker-Prager after Kupfer and Gerstle [16]

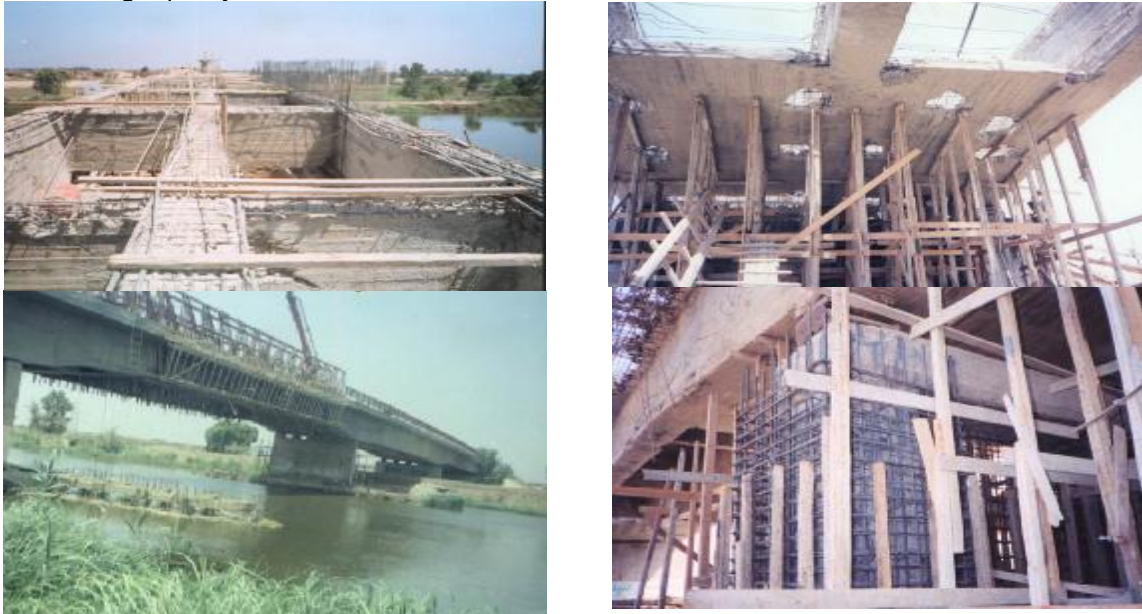
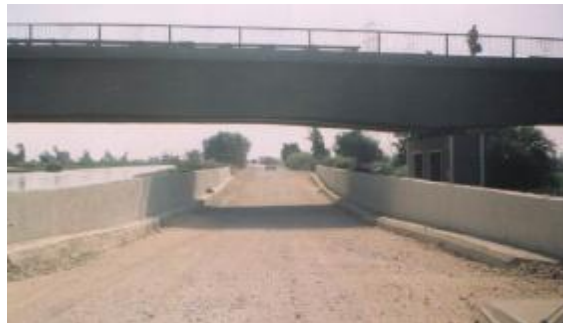
**Fig. 11: Remedy Process of Kheneza Bridge**

- d- For the beams of the overhanging span, a new concrete jacket was cast confining from all sides the old beams and connected using a bottom slab of thickness 15 cm in the 6.00 m from the supports to accommodate the new longitudinal compressive stresses.
- e- Demolishing of the superstructure side spans (simple spans) over the canal side banks due to the high corrosion and damage induced by the vehicle collision and recast using high quality concrete of C45.

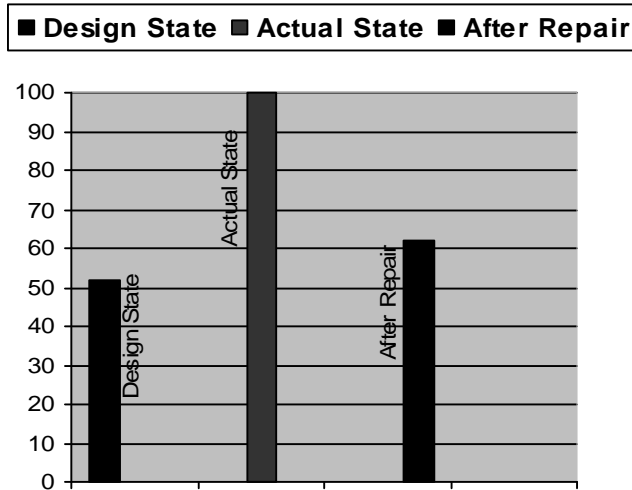
**Fig. 12: Service Conditions as a percent of the Actual State before Repair Process**

Design state : is the result of design values using 30-ton truck and concrete C300  
 Before Repair : is the state of 60-ton truck loading and deteriorated concrete state  
 After Repair : is the state after rehabilitation under 60-ton truck loading.

Finally, the finite element had been conducted using the repaired dimensions and concrete properties, where the following difference in the mid-span deflection is discernible as a percent of the design state and the final state after repair to the current deteriorated state "Fig. 12".

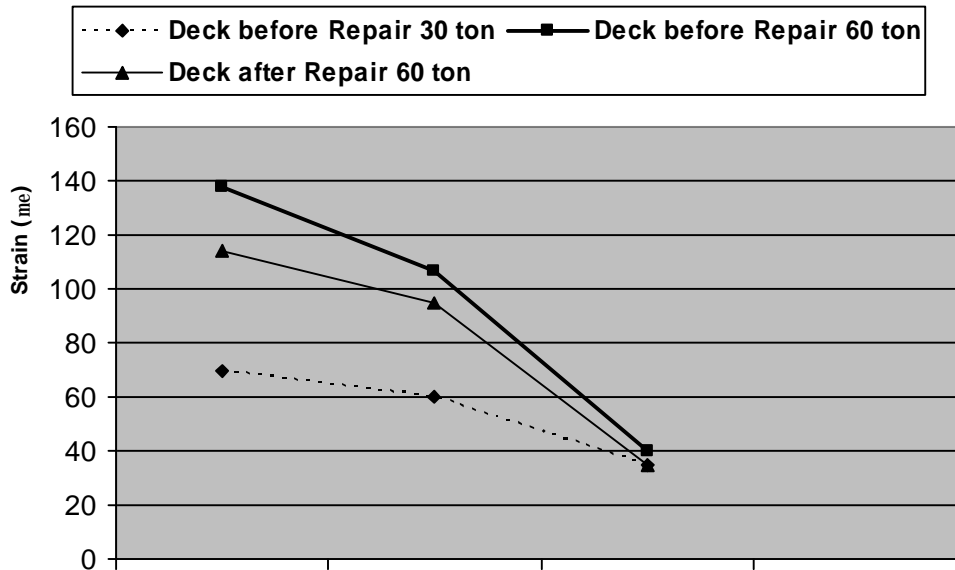
**Fig. 13: Strain at Mid span due to truck loading before and after repair**

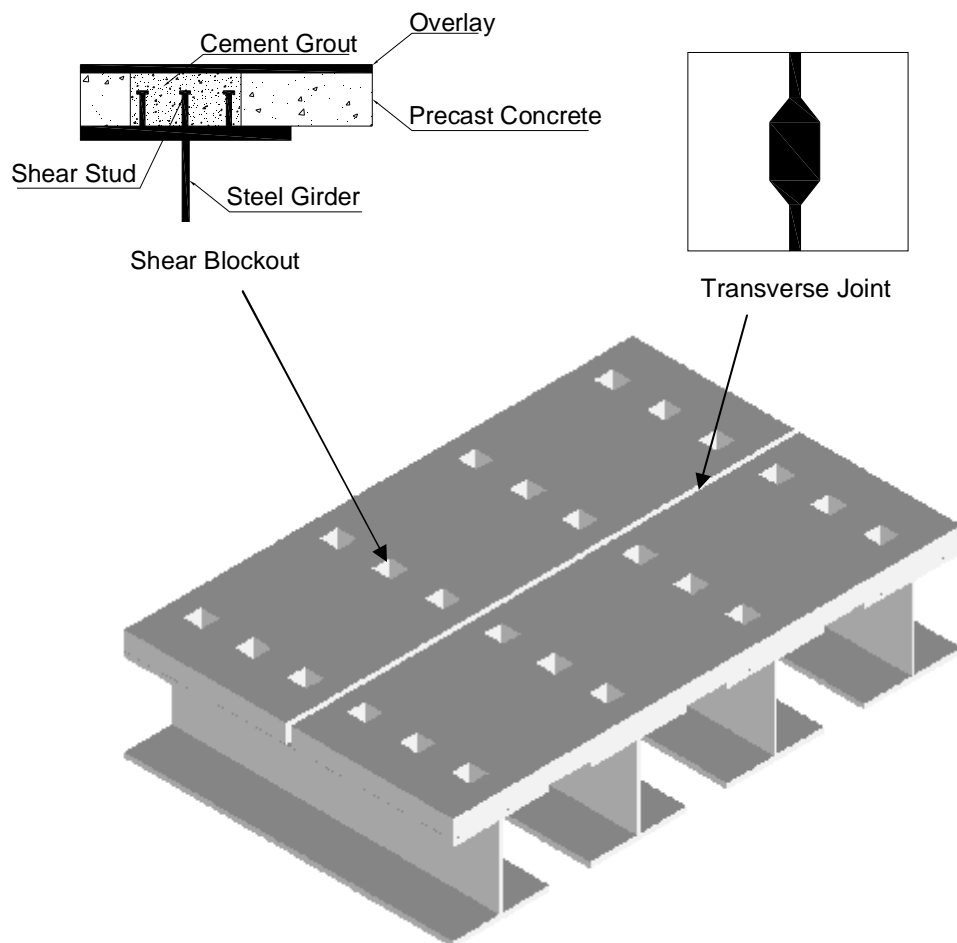
**Fig. 1: Scheme of a Full Depth Deck Panel [3]**

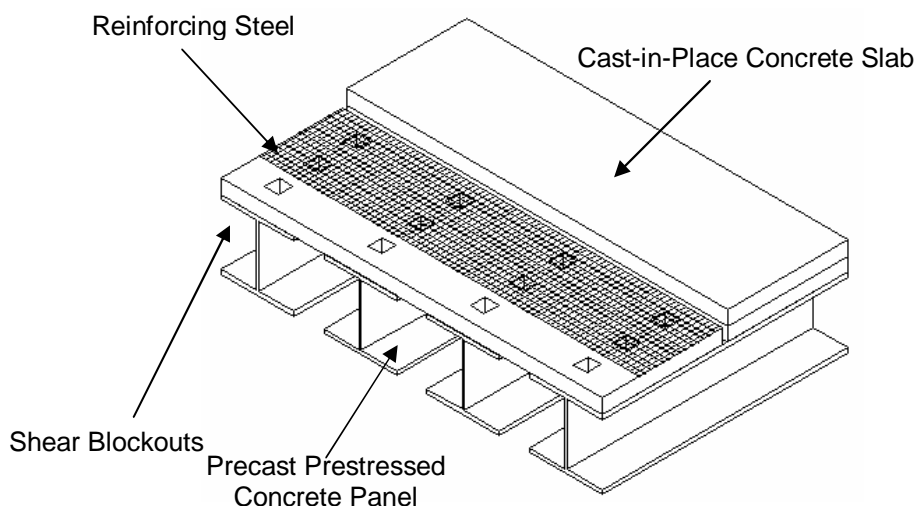
**Fig. 2: Scheme of a Half Depth Deck Panel [10]**

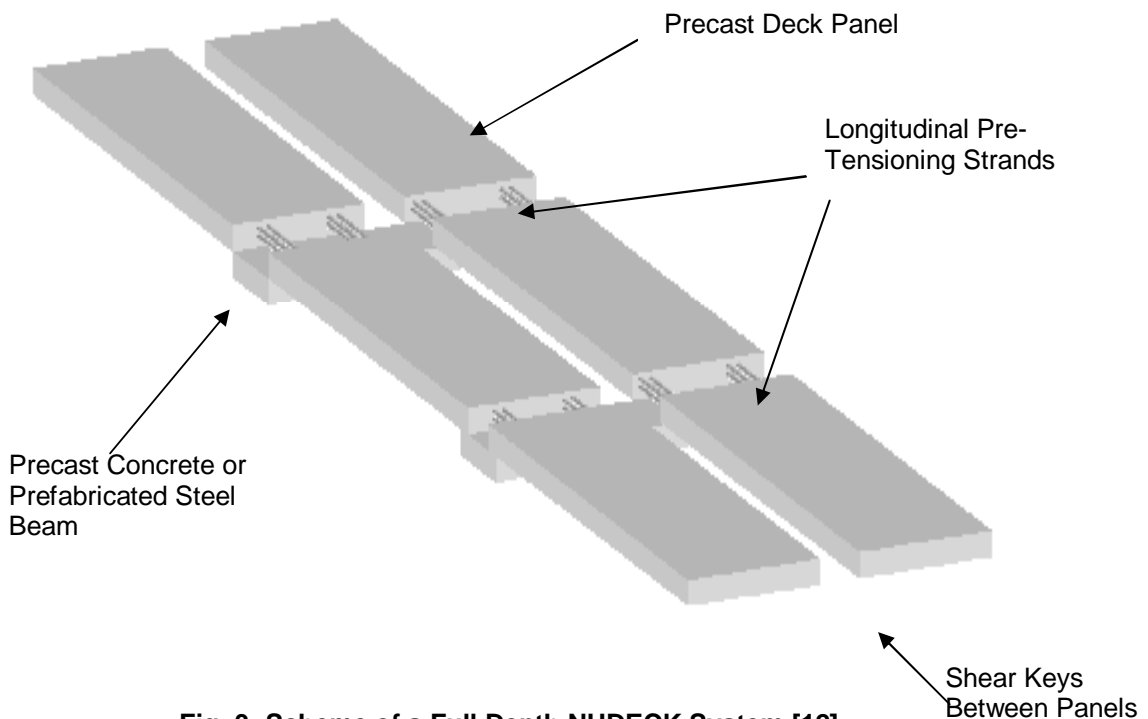
**Fig. 3: Scheme of a Full Depth NUDECK System [12]**

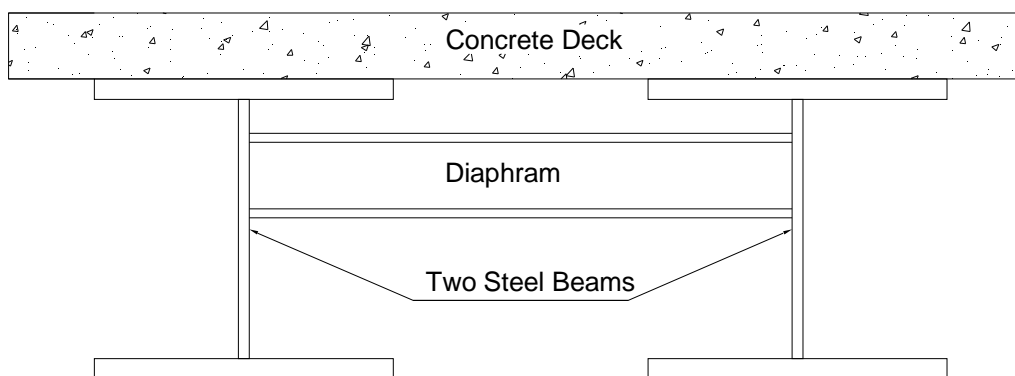
**Fig. 4: Scheme of Inverset Total Superstructure System [18]**

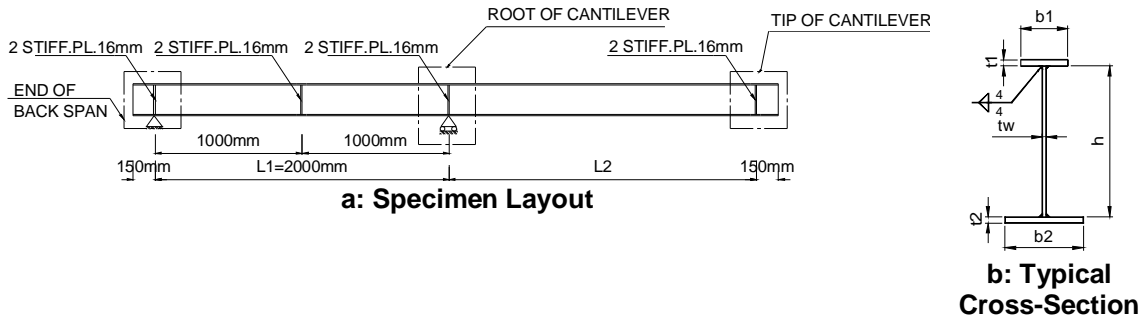
Fig. 1 Specimen Dimensions

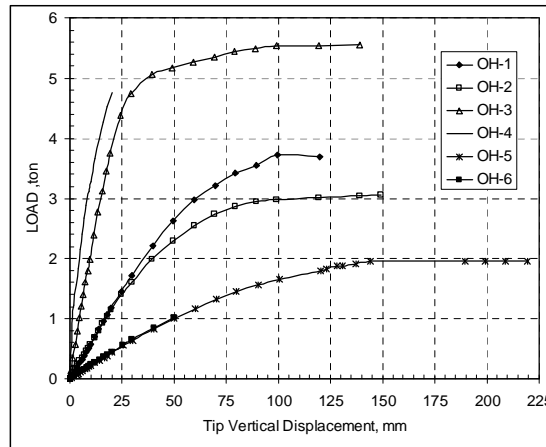
Fig. 8: Vertical Displacement Measured at the Tip of Cantilever Strain Measurements

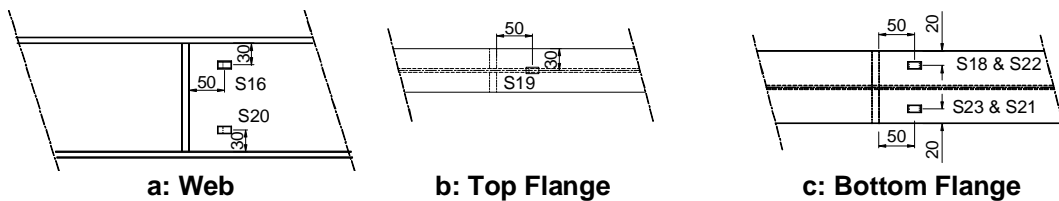
Fig. 9: Strain Gage Distribution at the Root of Cantilever

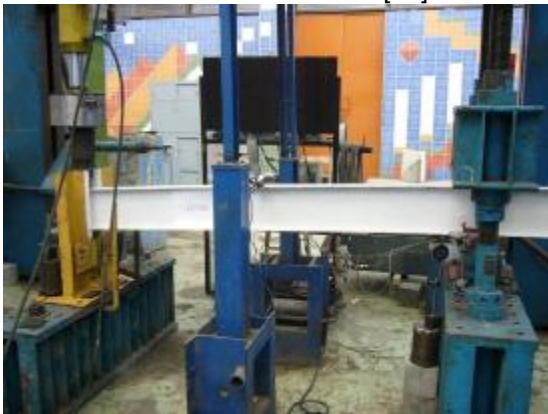
**Fig. 15: Specimen OH-1 at Failure Due to In-Plane Bending**

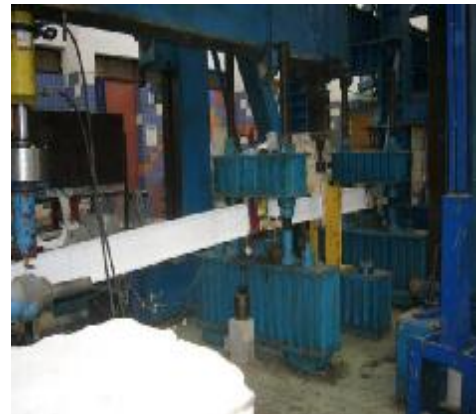
**Fig. 16: Specimen OH-2 at Failure Due to In-Plane Bending**

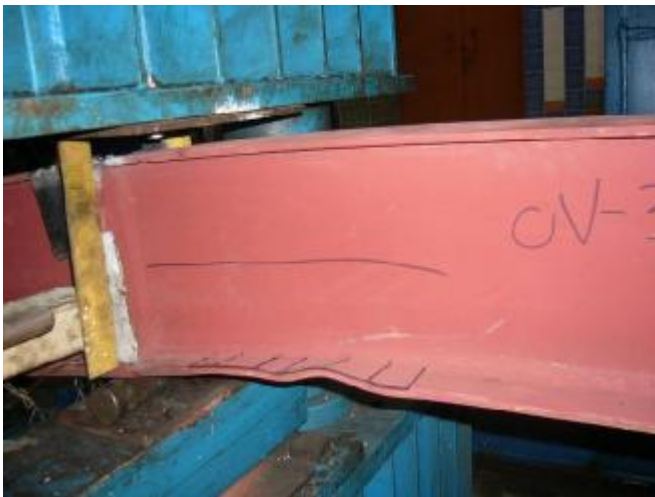
**Fig. 17: Specimen OH-3 at Failure Due to Local Buckling at Root**

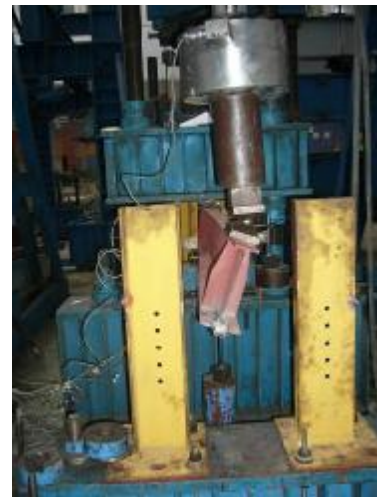
**Fig. 18: Specimen OH-4 at Failure Due to Lateral-Torsional Buckling**

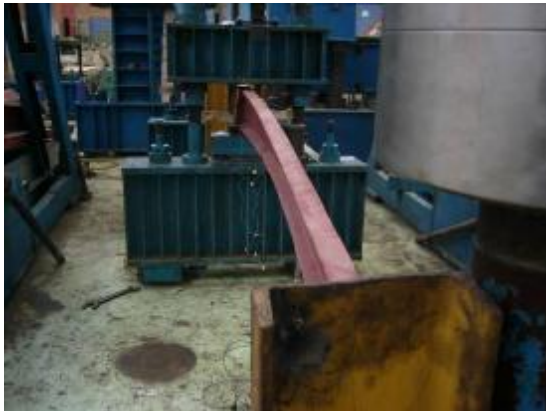
Fig. 19.a: Specimen OH-5 at Failure Due to Lateral Torsional Buckling

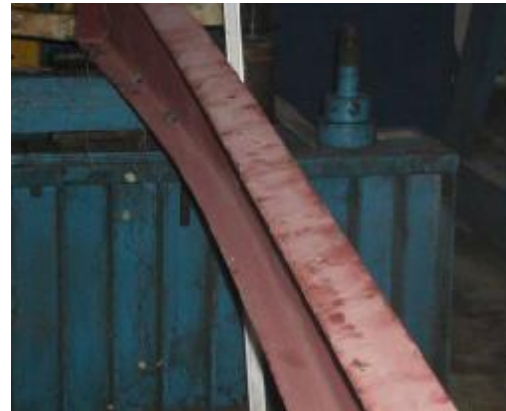
Fig. 19.b Specimen OH-5 at Failure Due to Lateral-Torsional Buckling, Maximum Lateral Displacement at Mid-Span of Cantilever

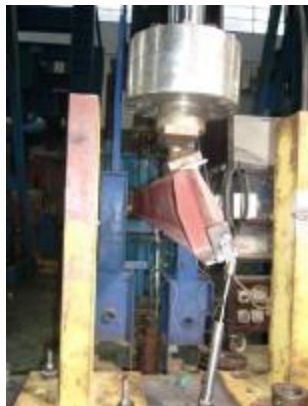
Fig. 20.a: Specimen OH-6 at Failure Due to Lateral Torsional Buckling

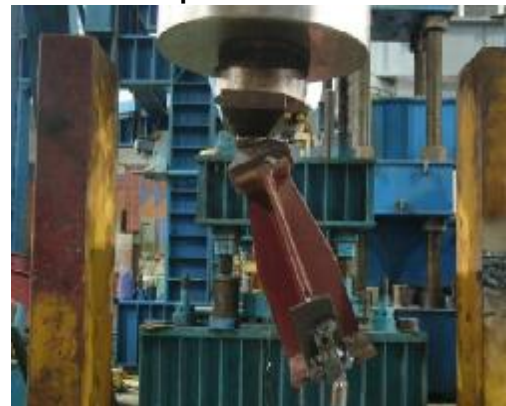
Fig. 20.b Specimen OH-6 at Failure Due to Lateral Torsional Buckling

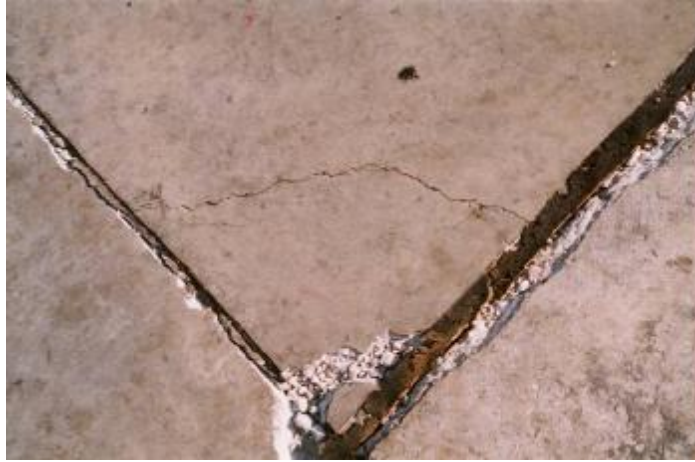
**Fig. 2: Circular Cracks Around the Corner of R.C. Slabs & Defects in Expansion and Shrinkage Joints.**

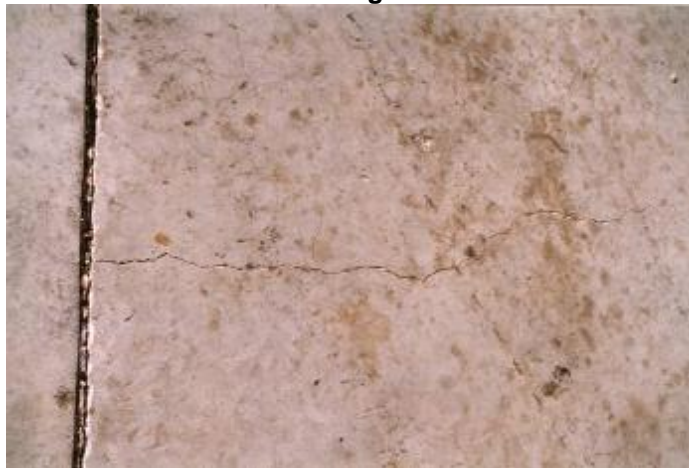
**Fig. 3: Cracks Parallel to Short Direction of R.C. Slabs and Perpendicular to Traffic Flow Direction**

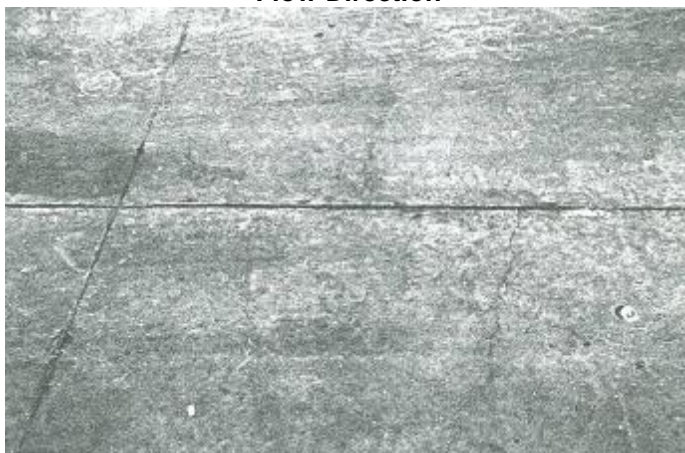
**Fig. 4: Cracks Along the Middle of Some Slabs, Parallel to Short Direction of R.C. Slabs and Perpendicular to Traffic Flow Direction.**

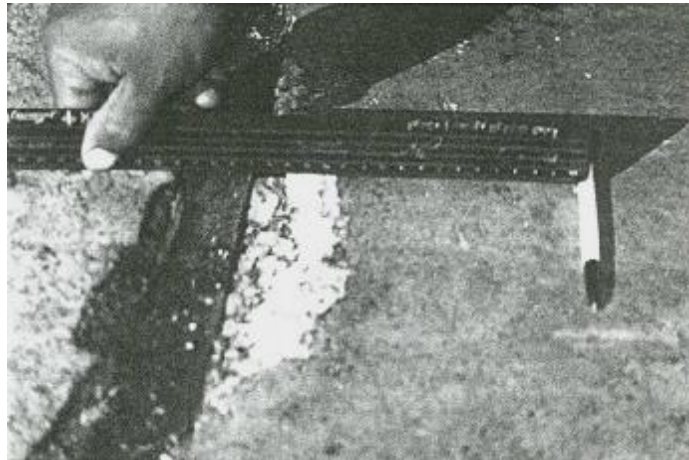
**Fig. 5: Relative Settlements between Adjacent R.C. Slab Segments.**

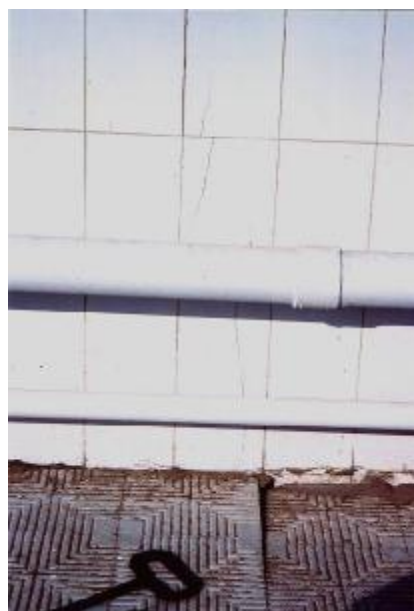
**Fig. 6: Cracks in Tiles of End Walls and Separation between End Walls and Floor Tiles, due to Tilting of Retaining Wall Around the Station.**

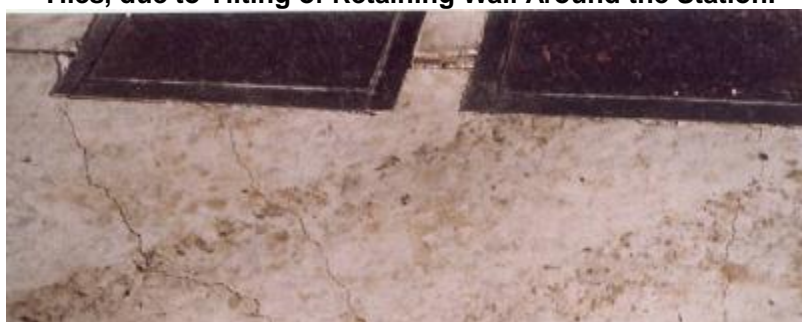
**Fig. 7: Cracks Around Electrical and Sanitary Inspection Chambers.**

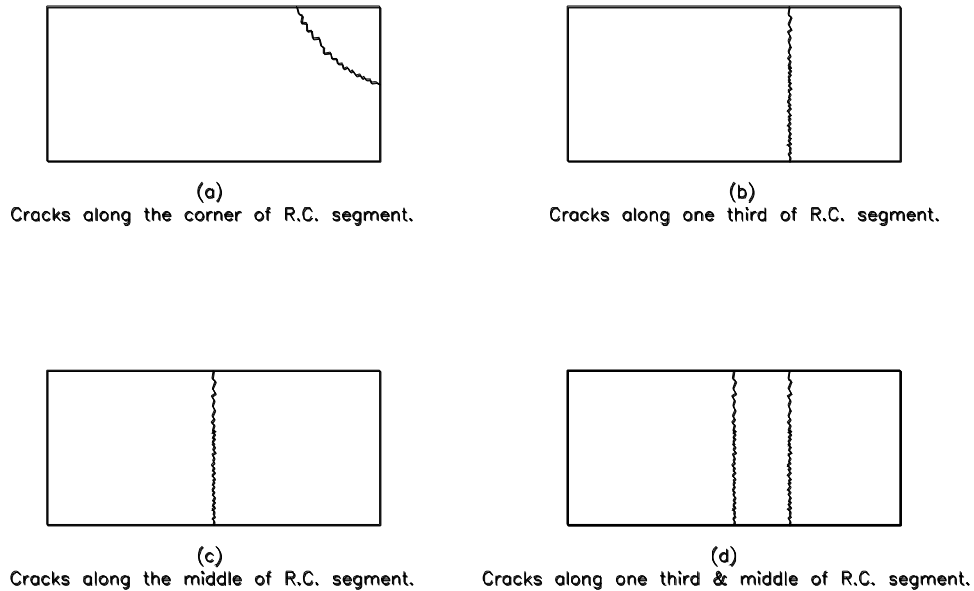
**Fig. 8: Locations of Cracks in the R.C. Slab Segments of Gas Station**

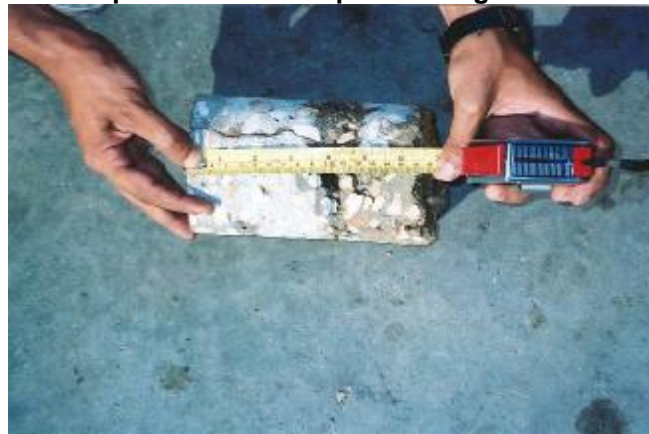
**Fig. 11: Sample of Core Test at Cracked Section (Sample # 1), Showing a Total Concrete Depth of 16 cm and RFT Mesh at Depth 10 cm from Top Surface.**

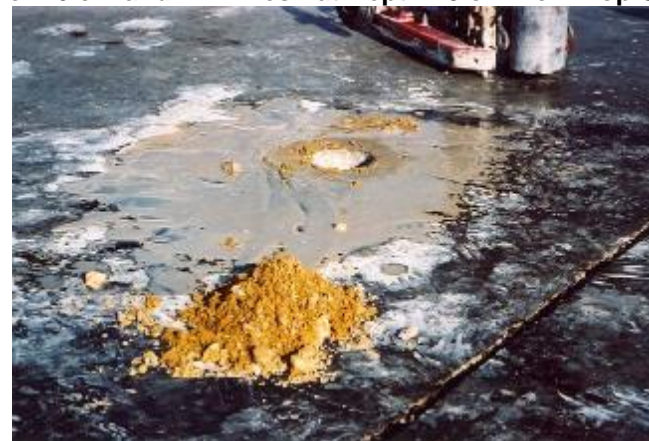
**Fig. 12: Core Test Extended, in Depth, Through Base Material.**

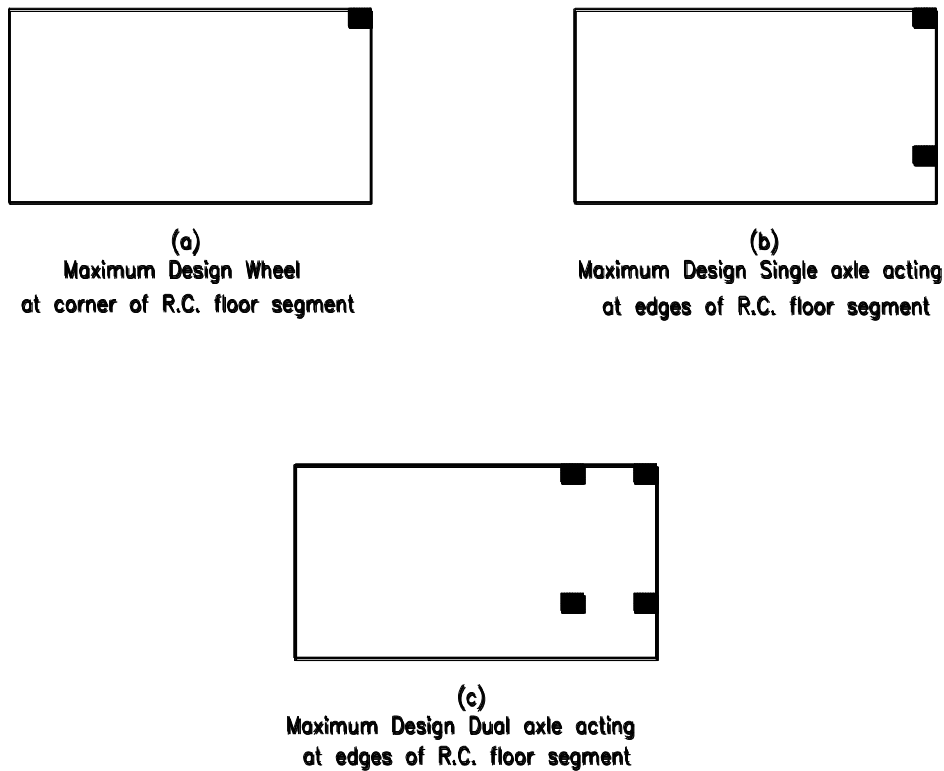
**Fig. 13: Cases of loading used in the station**

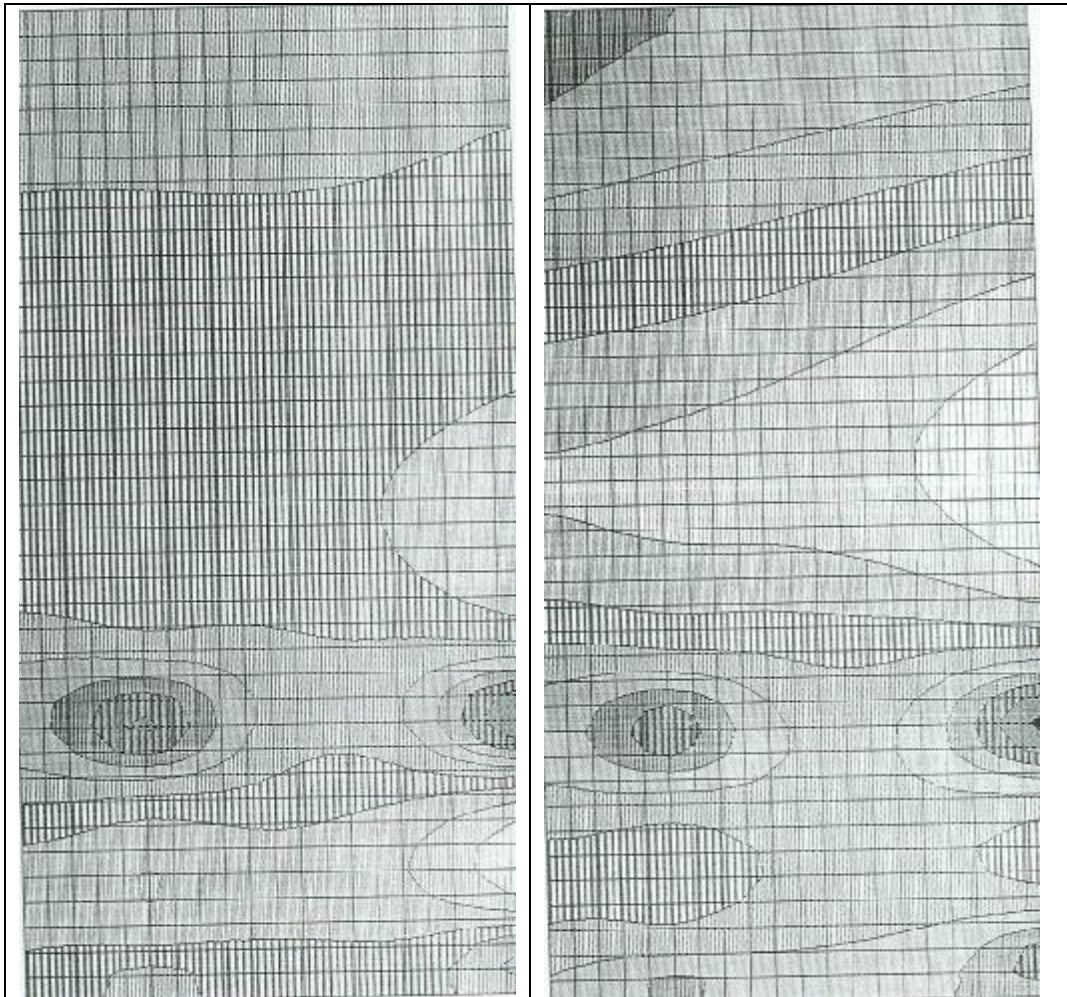
(a) Case: Floor-1B,  $M(\text{max.})=0.88 \text{ m.t./m}$

moments in the slab is almost tripled from 0.84 ton. meter/meter to 2.45 ton.meter/meter. Accordingly, the moment exceeds the cracking resistance of the slab resulting in cracks occurrence at the one-third of it, as illustrated on the net of moment contour lines of the moment for the different cases.

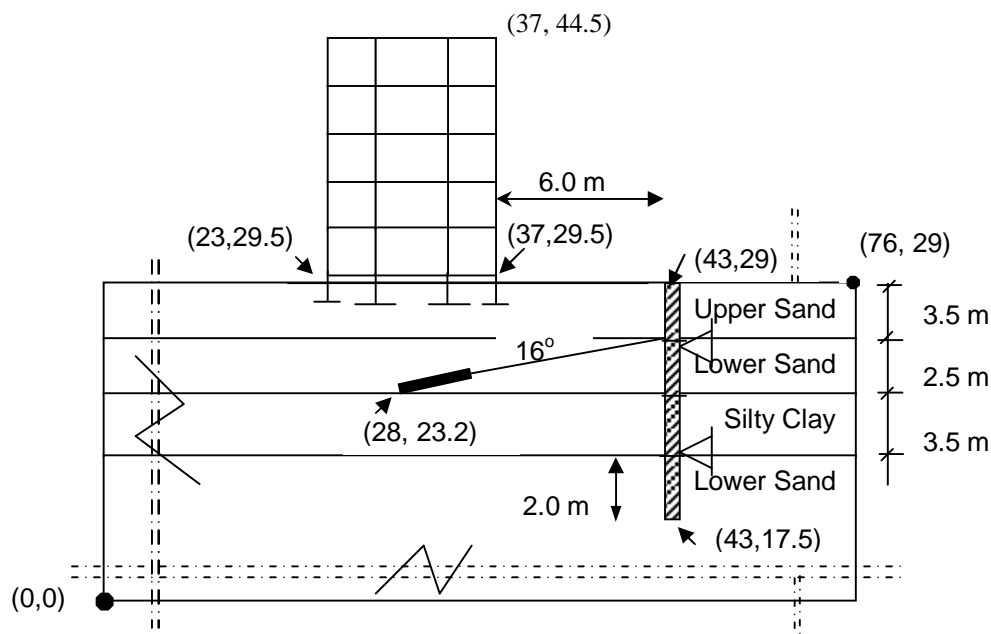
**Fig. 1: Systematic Diagram Showing a Sketch of The Problem**

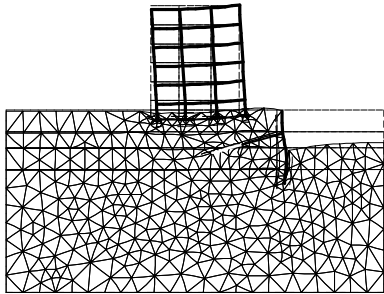
**Fig. 7: Building Deformation, phase4      Fig. 8: Building First Floor Displacement, phase4**

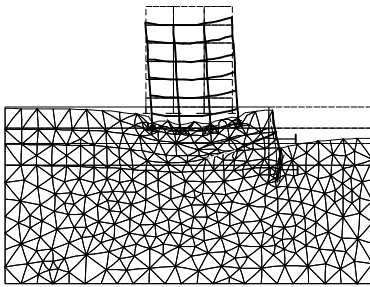
**Fig. 10: Deformed Mesh, phase 6**

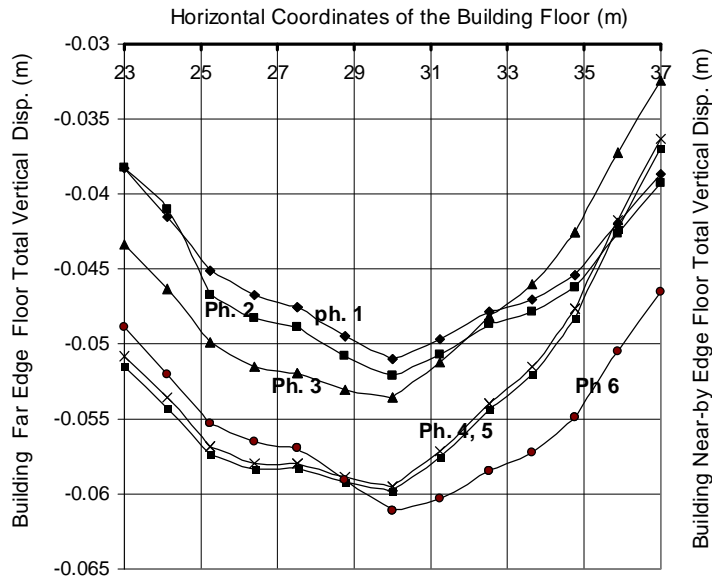
**Fig. 14: Building First Floor Total Vertical Displacement During Different Phases of Diaphragm Wall Construction**

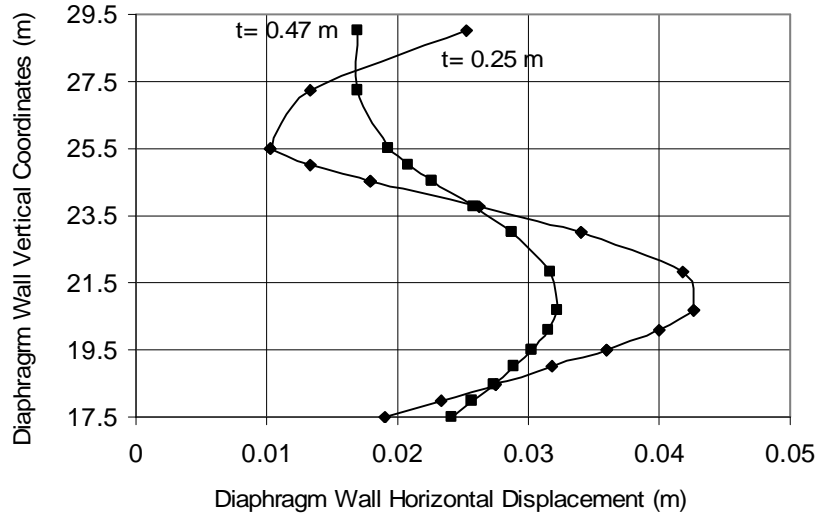
**Fig. 18: Effect of Changing Diaphragm Wall Thickness (t) on Horizontal Displacement, phase 4**

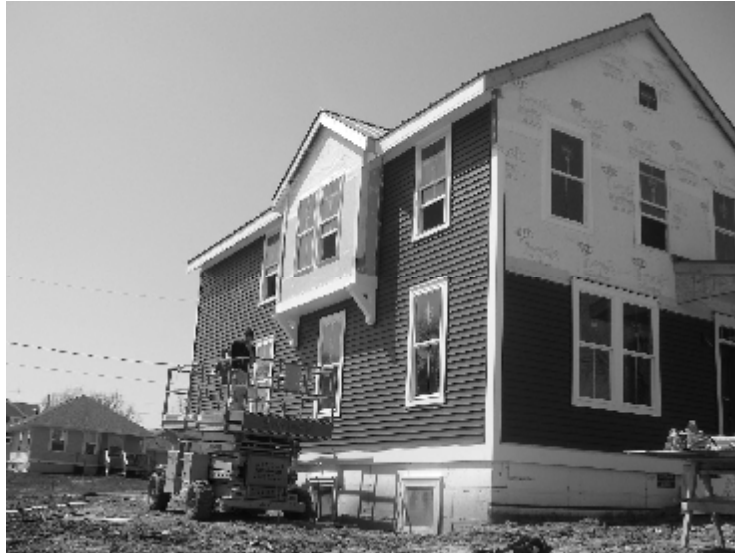
**Fig. 2: Vinyl Siding**
