## Contents

## EFFECT OF AGGREGATE TYPE ON THE BEHAVIOR OF THERMALLY TREATED SELF-COMPACTED CONCRETE

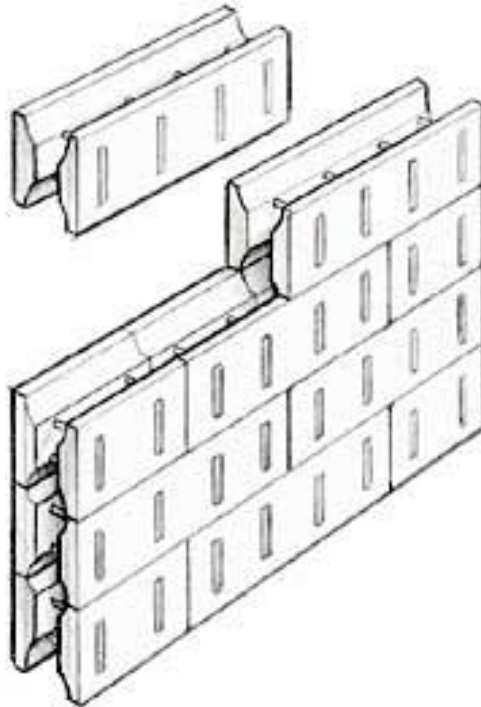
**Fig. 3: Insulated Concrete Form**

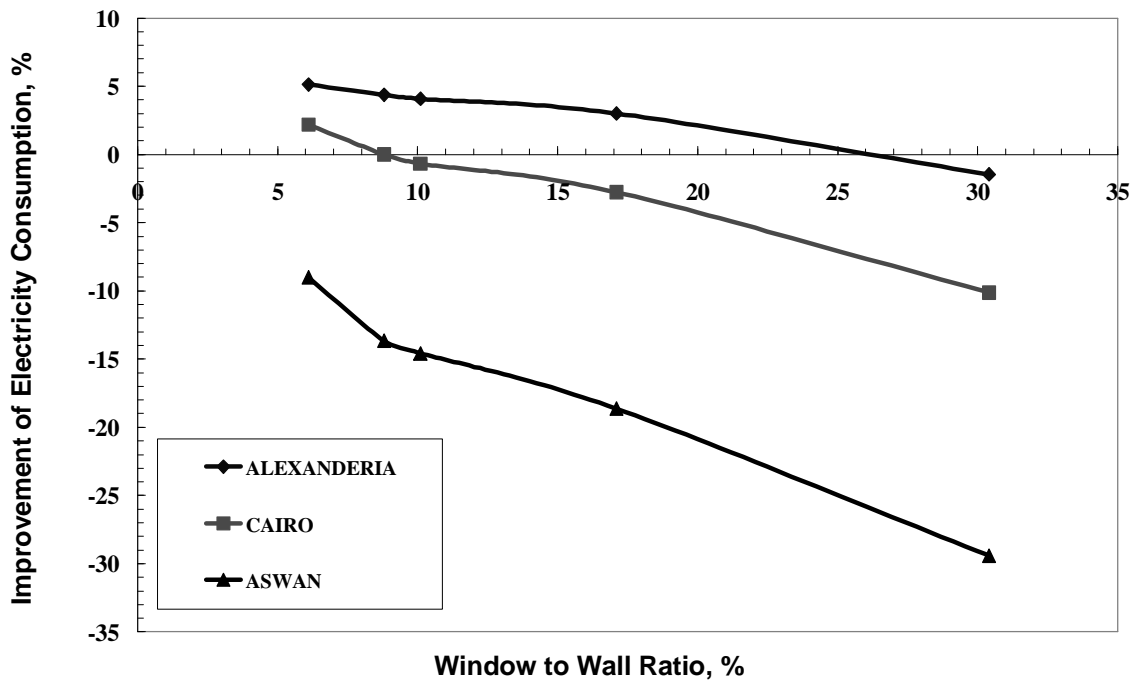
Fig. 2: Effect of Window to Wall Ratio on Improvement of total Electricity Consumption for Ramadan Apartment with Different Climatic Conditions

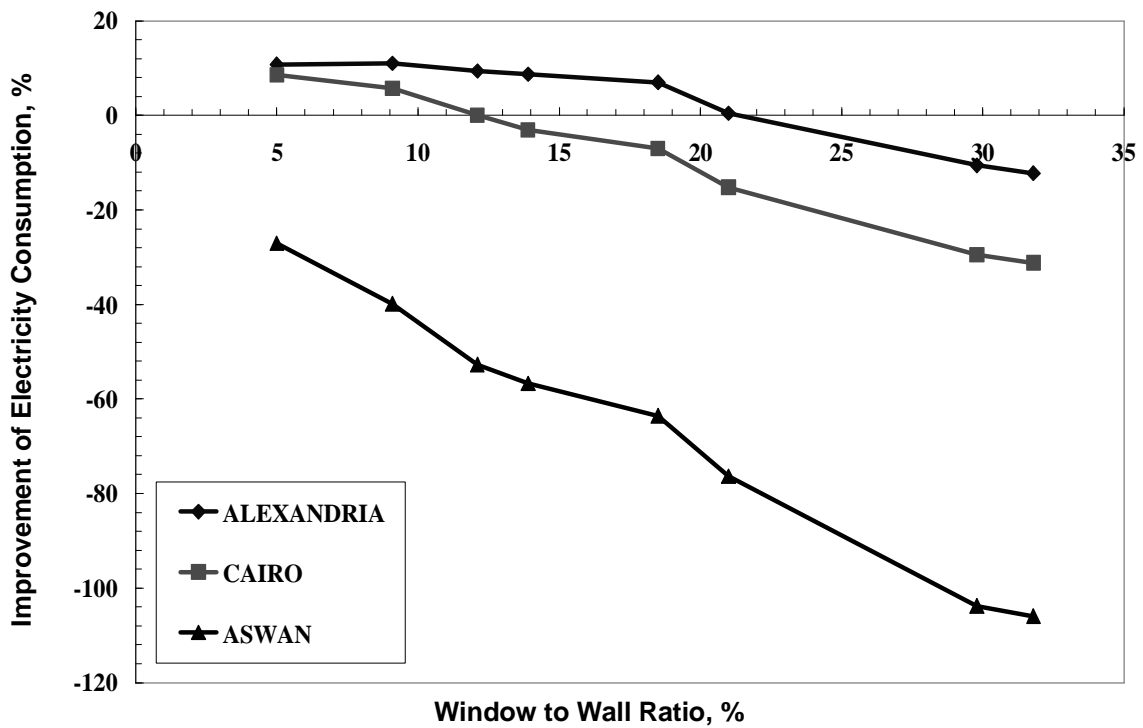
Fig. 3: Effect of Window to Wall Ratio on Improvement of Total Electricity Consumption for Ghazala Apartment with Different Climatic Conditions

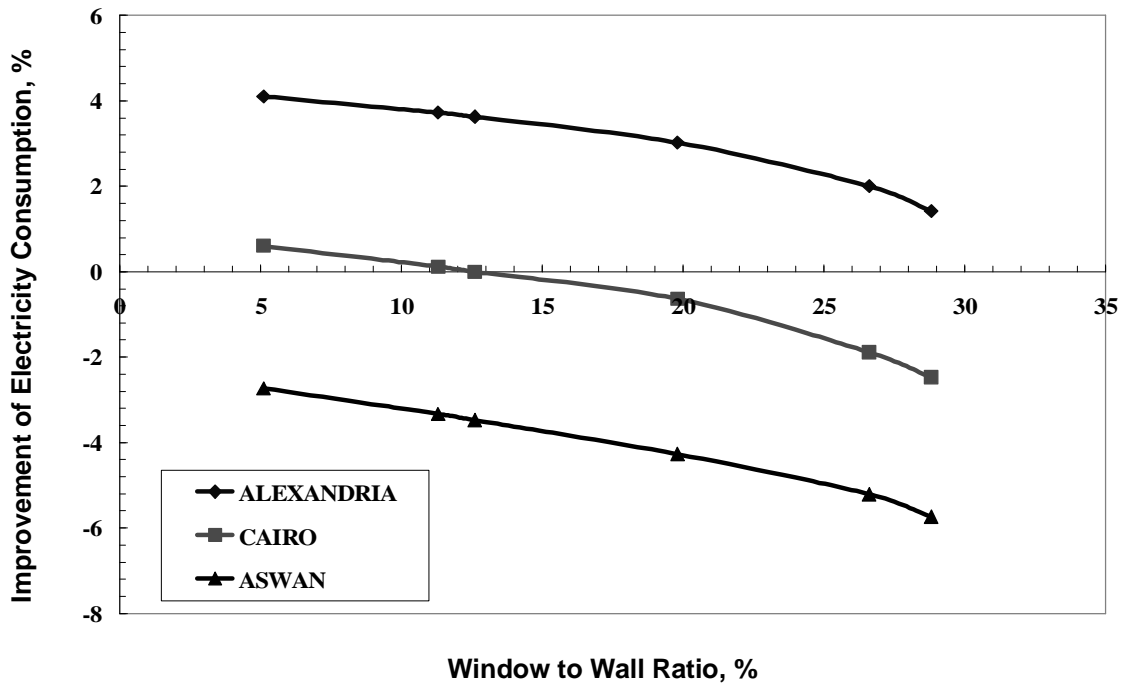
Fig. 4: Effect of Window to Wall Ratio on Improvement of Total Electricity Consumption for Electricity Building with Different Climatic Conditions

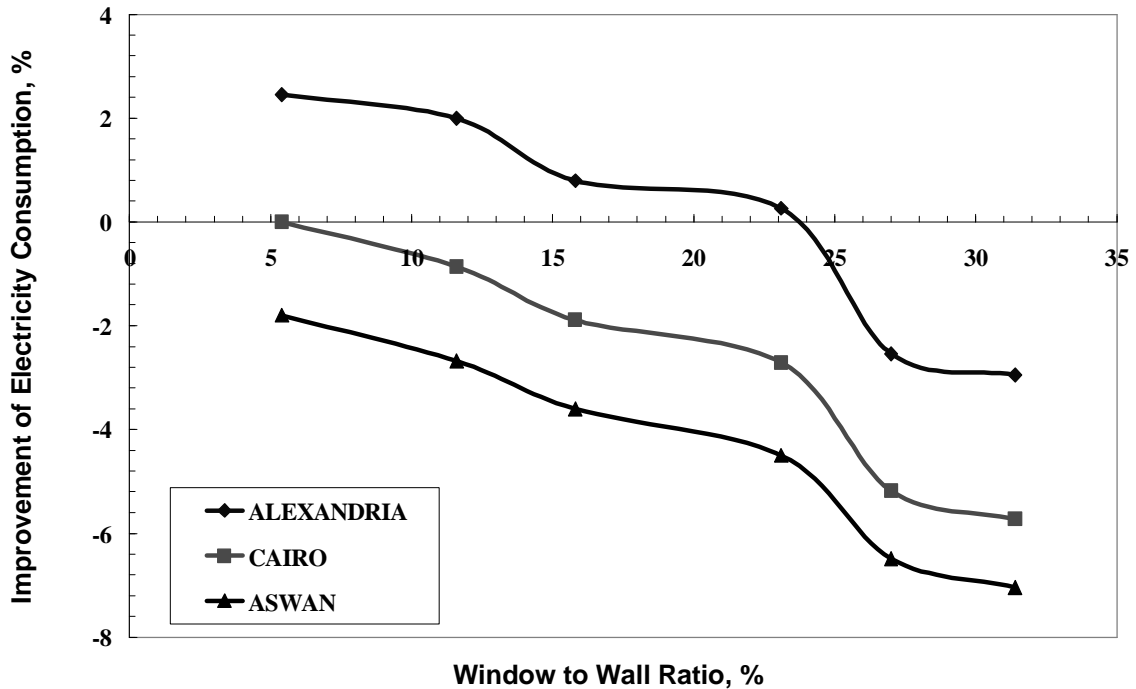
Fig. 5: Effect of Window to Wall Ratio on Improvement of Total Electricity Consumption for Omar-Effendi Building with Different Climatic Conditions

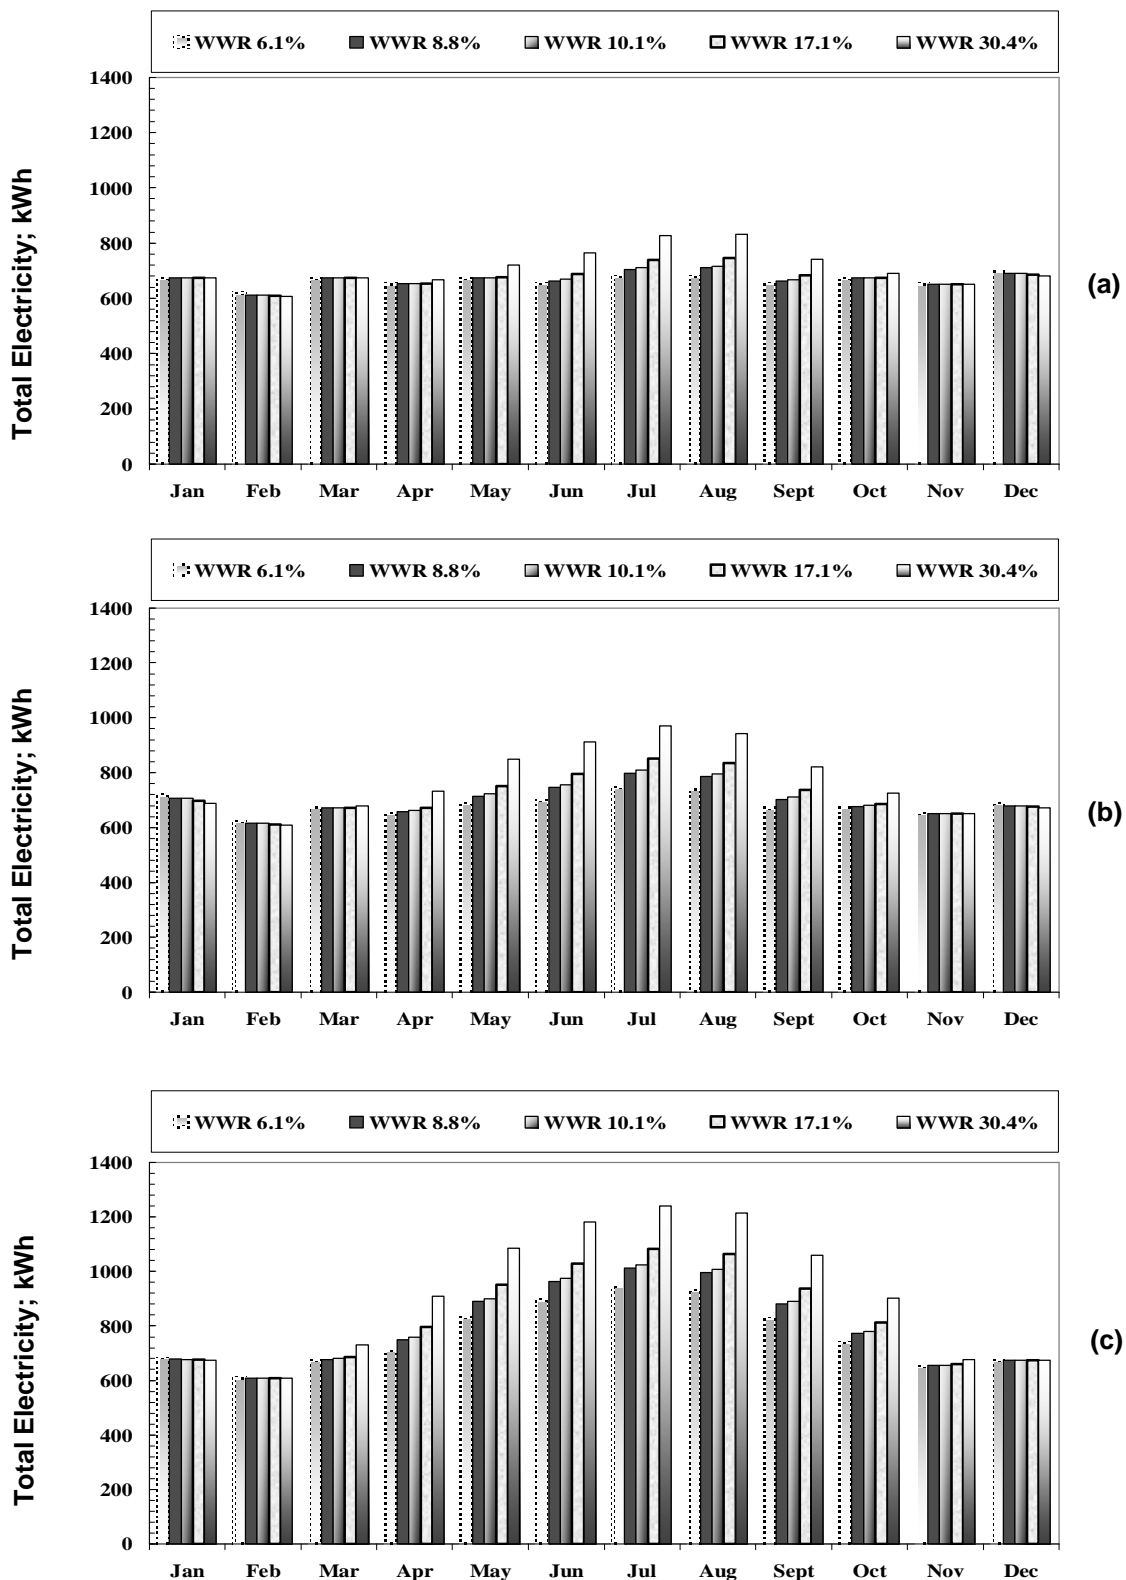
Fig. (6): Monthly Total Electricity for Ramadan Apartment with Different Window to Wall Ratios at Climatic Conditions of (a) Alexandria (b) Cairo (c) Aswan

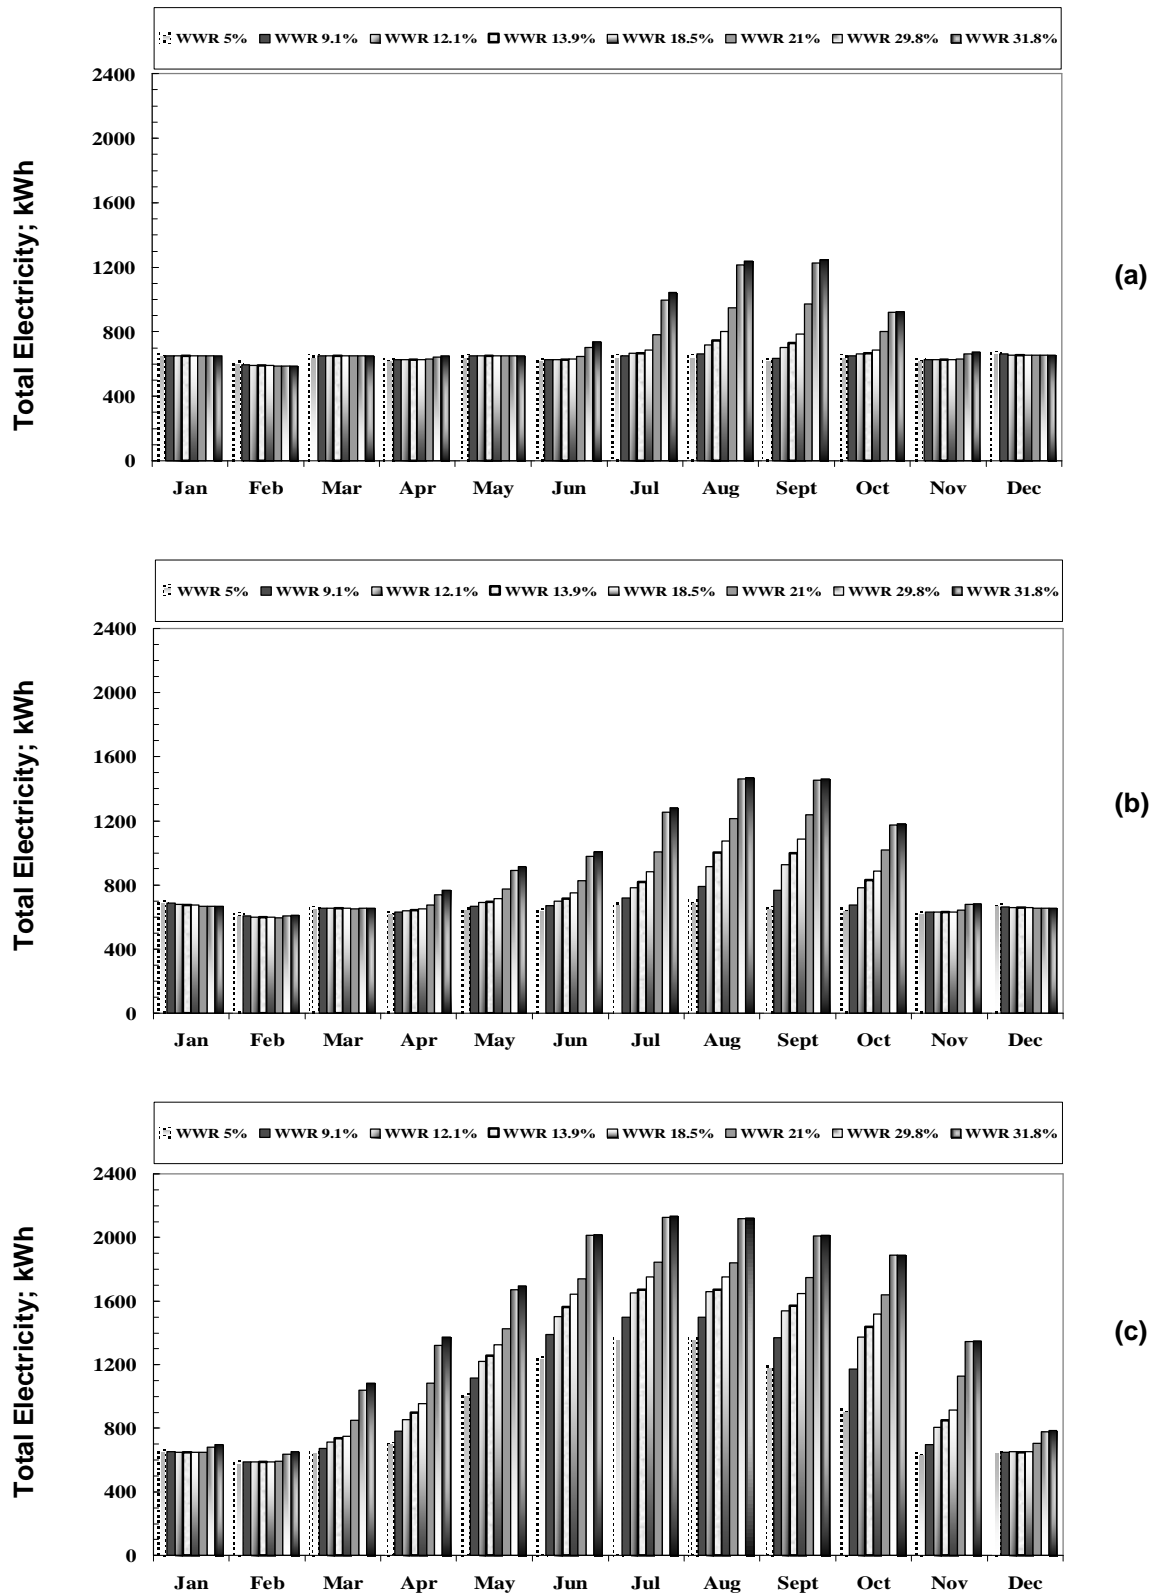
Fig. 7: Monthly Total Electricity for Ghazala Apartment with Different Window to Wall Ratios at Climatic Conditions of (a) Alexandria (b) Cairo (c) Aswan

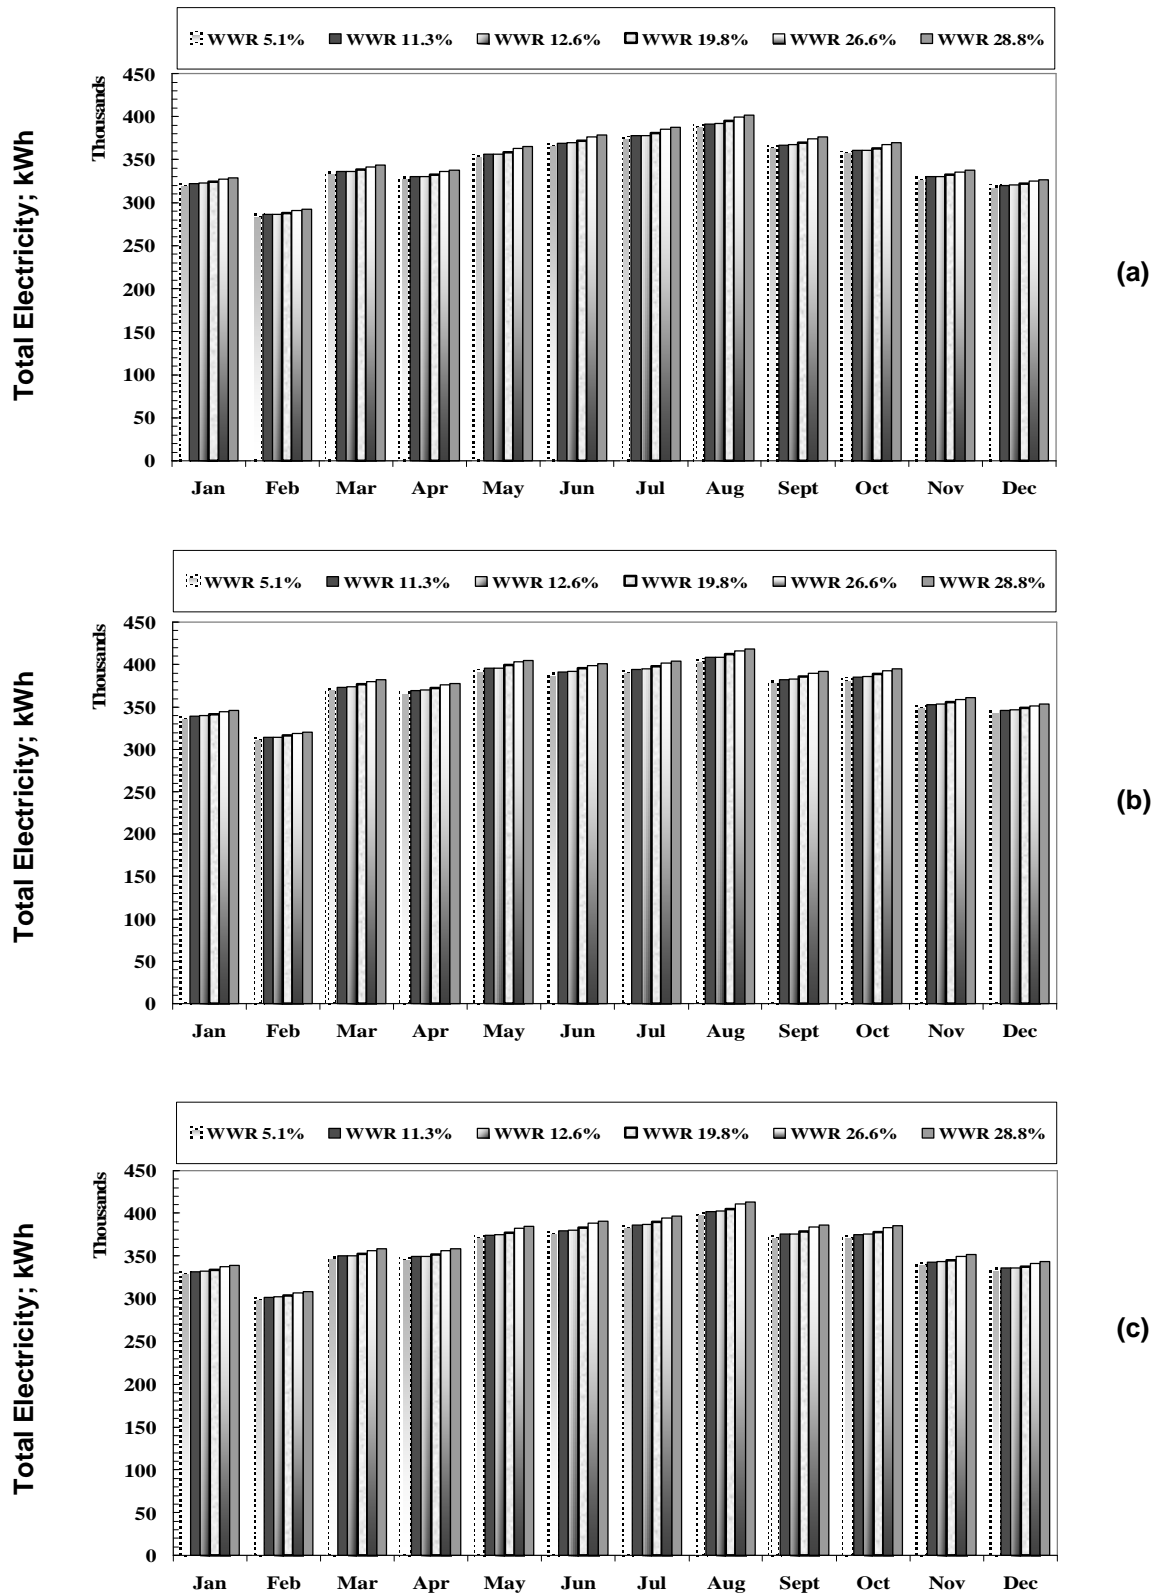
Fig. 8: Monthly Total Electricity for Electricity Building with Different Window to Wall Ratios at Climatic Conditions of (a) Alexandria (b) Cairo (c) Aswan

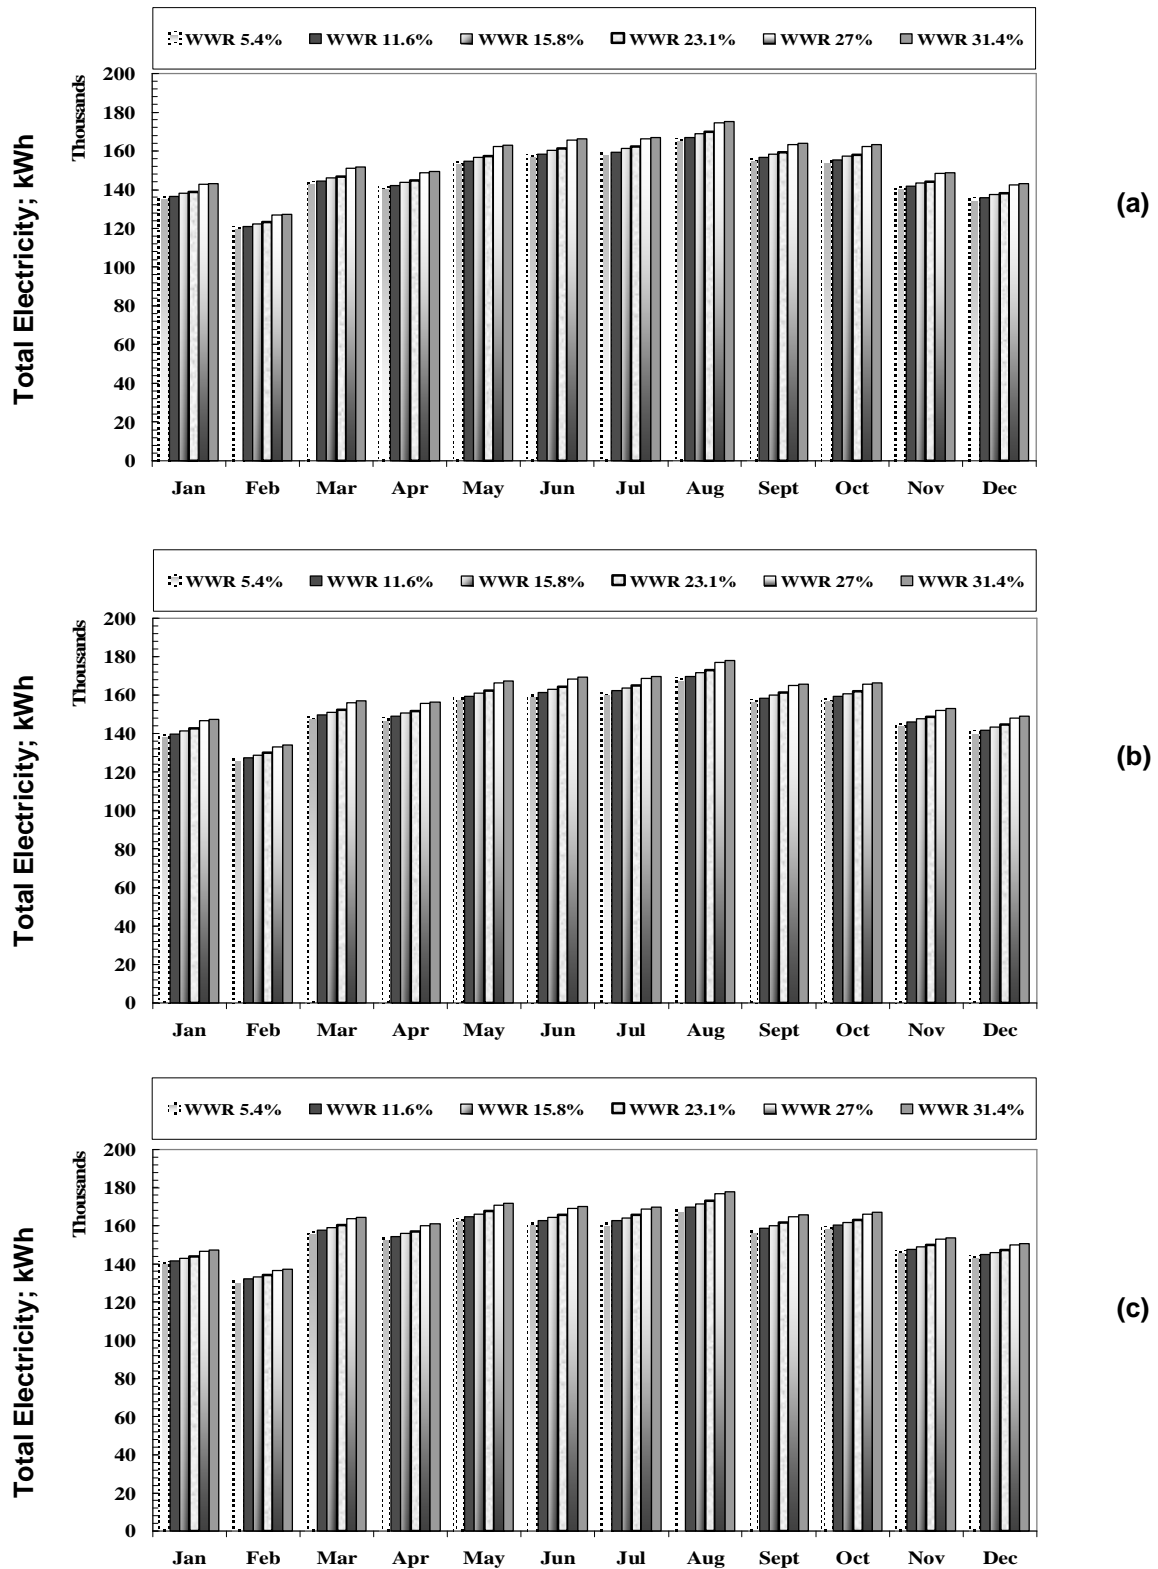
Fig. 9: Monthly Total Electricity for Omar-Effendi Building with Different Window to Wall Ratios at Climatic Conditions of (a) Alexandria (b) Cairo (c) Aswan
